Project #Y174107

December 20, 2019

**Subject: Engineering Geologic Investigation
for Oceanfront Protection Along Siletz Spit
between Tax Lot 156, Map 08-11-09DD
and Tax Lot 200, Map 07-11-34CB
Lincoln County, Oregon**

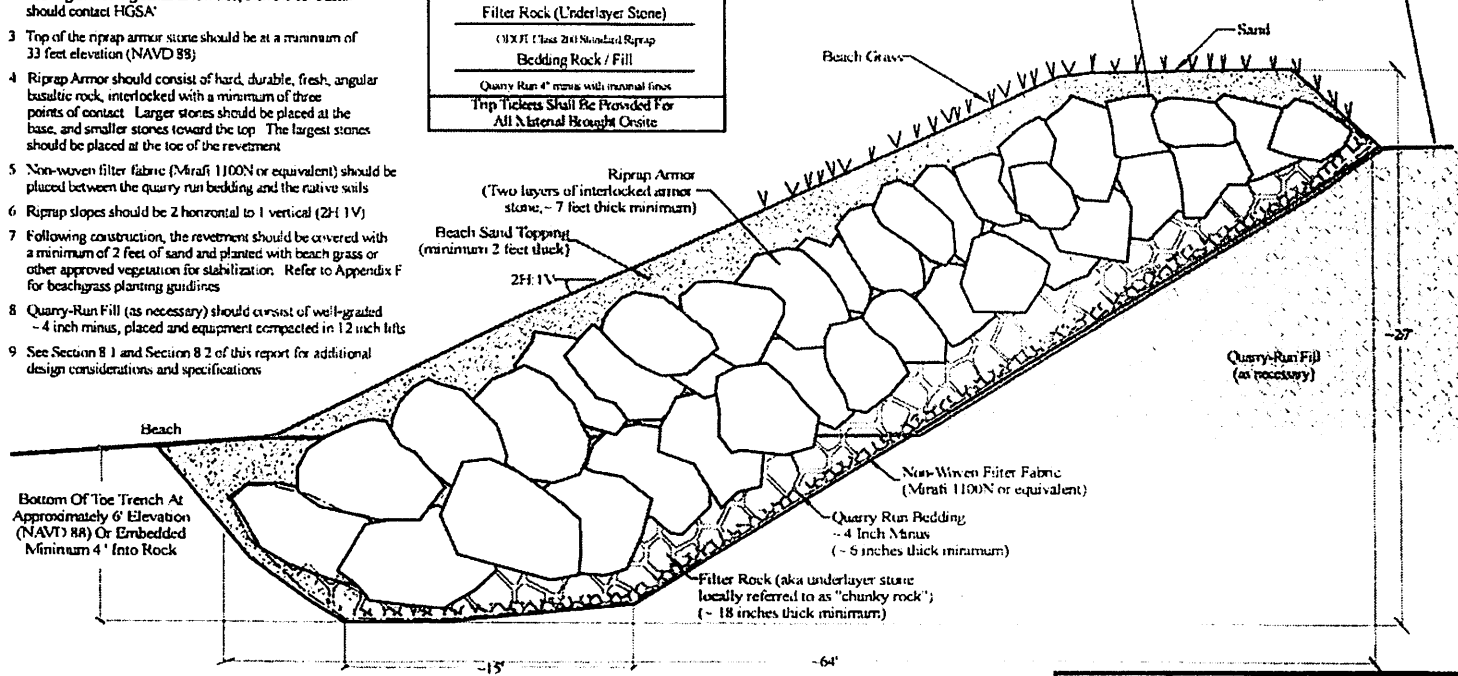
Eastern Edge Of The Top Of Revetment Located At Least 20' West Of Westernmost Foundation Element And Aligned With Other New Revetments

Top Of Riprap Armor At Minimum 33' Elevation (NAVD 88)
Existing Grade Of Foredune Crest Is Approximately 30' Elevation (NAVD 88) Throughout Site

Existing grade of dune
Non-Woven Filter Fabric (Mirafi 1100N or equivalent)

- 1 Base of the riprap should be embedded at approximately 6 feet elevation (NAVD 88). The final revetment embedment depth should be as deep as "flowing/heaving" sand conditions at low tide allow. If bedrock is encountered in the excavation, the toe of the revetment should be embedded a minimum of 4 feet into bedrock.
