**Subject: Preliminary Assessment Report
Proposed Shoreline Protection
Beach Grass Lane Common Area
Tax Lots 08-11-09-AA-00235-00 and 08-11-09-AD-00139-00
Gleneden Beach, Lincoln County, Oregon
EEI Report No. 23-288-1**

PRELIMINARY ASSESSMENT REPORT

**Proposed Shoreline Protection
Beach Grass Lane Common Area
Tax Lots 08-11-09-AA-00235-00 and 08-11-09-AD-00139-00
Gleneden Beach, Lincoln County, Oregon**

EEl Report No. 23-288-1

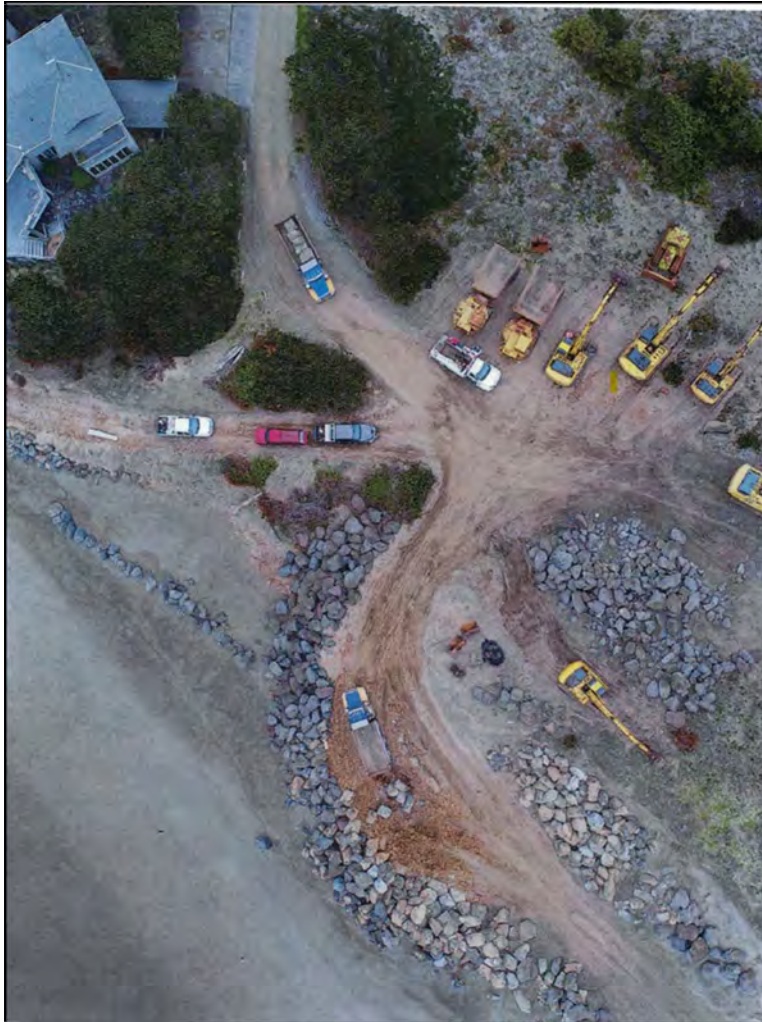
Figure 1: Aerial image of the northern portion of the Beach Grass Lane common area property, with improvements (grading, imported rock, slope stabilization, etc.) to allow construction equipment and emergency vehicle access to the Salishan Spit shoreline area (photo provided by client).

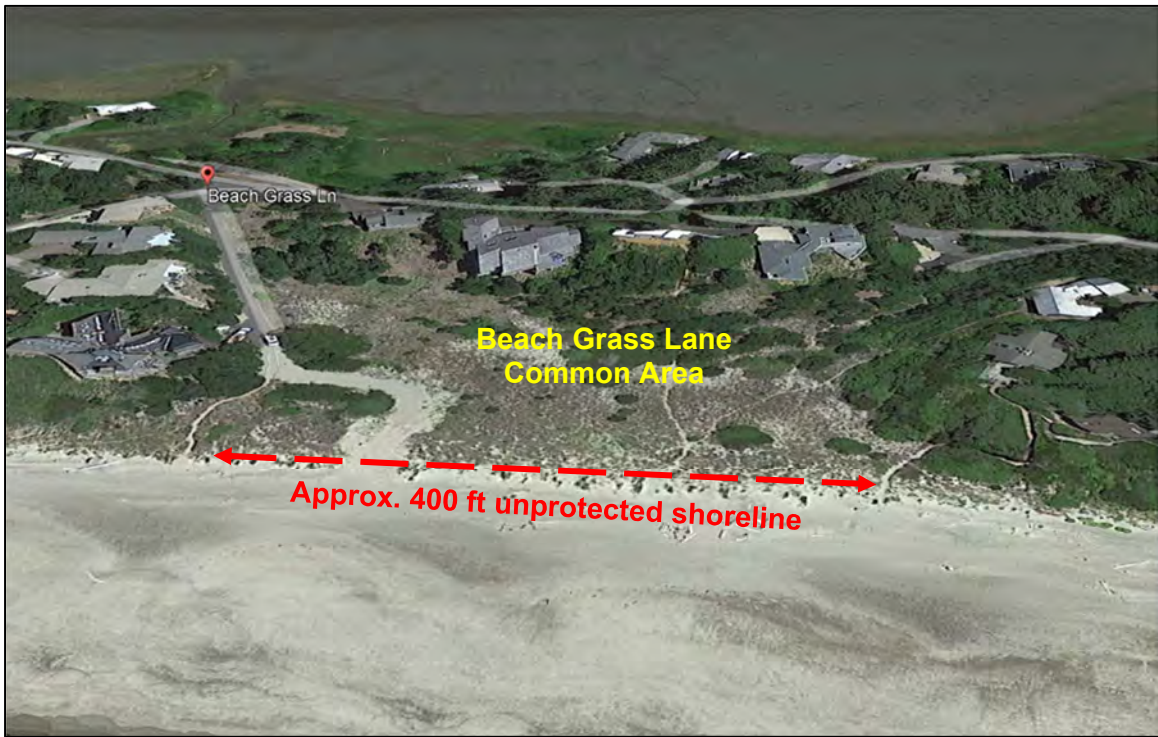
The property has beach frontage of approximately 400 feet, with no shoreline protection currently in place. Figure 3 below shows the unprotected shoreline of the common area, and the site conditions can be seen below in Photos 1 through 7.

Figure 3: Google Earth image of the approximately 400 linear feet of unprotected beach frontage (imagery date: July 13, 2022)

To mitigate future ocean wave erosion and the resulting dune recession, support the oversteepened dune, and protect the neighboring houses from damage, we recommend that a riprap revetment be constructed. When pursuing permanent protection of the property, a rip rap revetment along the full oceanfront length of the property is recommended.

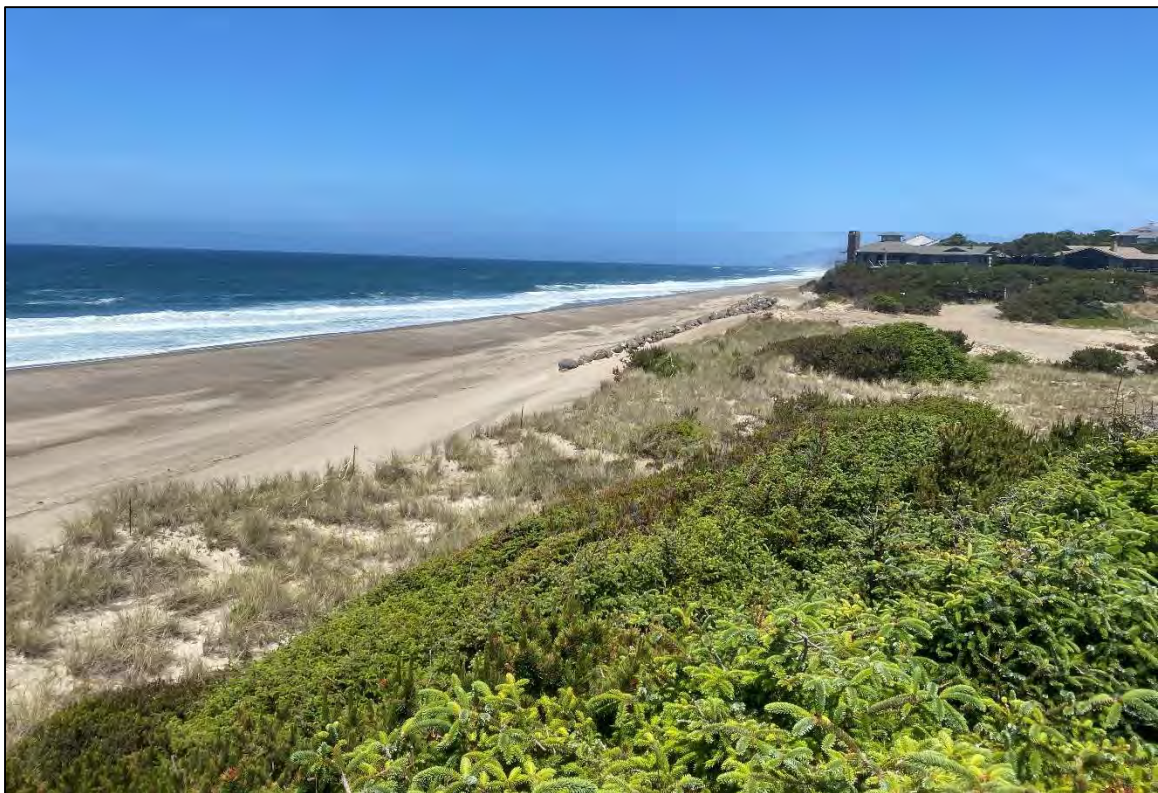
Photo 1: View of the park looking north (photo date: June 15, 2023).

The property is surfaced with dune sand, and typically denuded of vegetation on the west facing slope. Elsewhere, the common area and dune crest are vegetated with wild grasses and native shrubs.

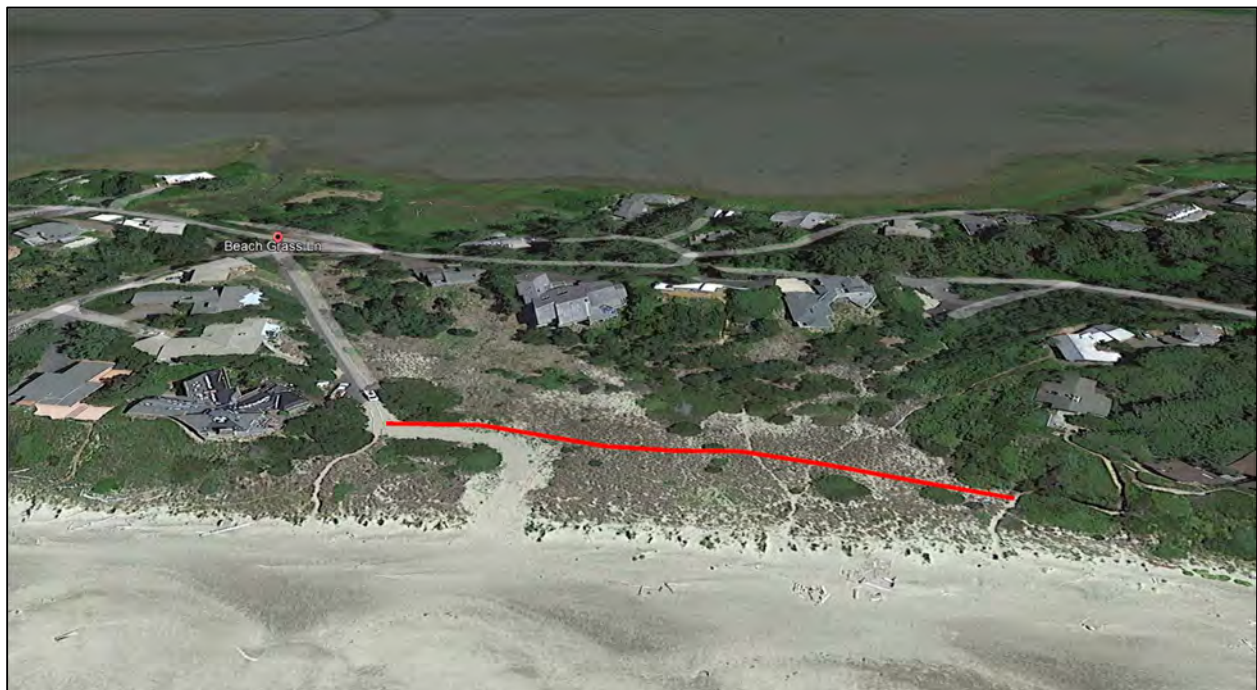
EEl visited the site on both January 11, and February 9, 2024 to observe the rapid ongoing erosion. Figure 4 below shows the extent of the erosion observed at the time of our visit on February 9, 2024; the red line marks the top of the slope. This is a significant eastward movement of the slope crest between the image date of July 13, 2022 and our GPS measurements taken on February 9, 2024.

Figure 4: The extent of the erosion observed on February 9, 2024, as shown by the red line.
(Google Earth imagery date: July 13, 2022)

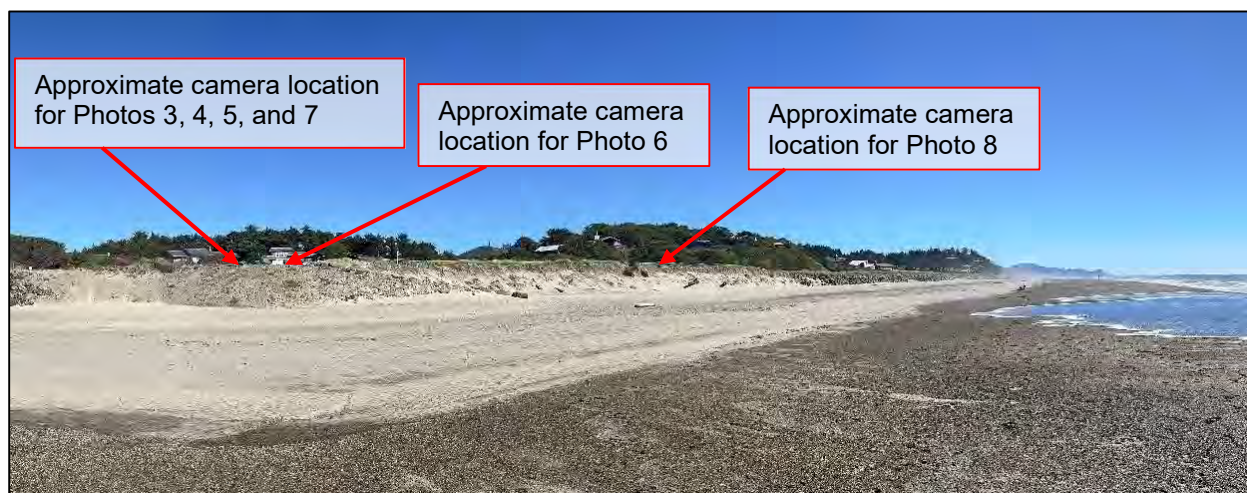
The shoreline of the subject property is rapidly changing as evidenced by the differences observed in Photo 2 (dated August 10, 2023) versus Photos 3 through 8 taken in January and February, 2024. Photo 4 (January 9, 2024) was extracted from a SLI-provided video of wave run-up and erosion occurring on the subject property. Photo 5 was taken by EEl during a site visit on

Photo 2: Looking southwest towards the subject property (client-provided photo dated August 10, 2023).

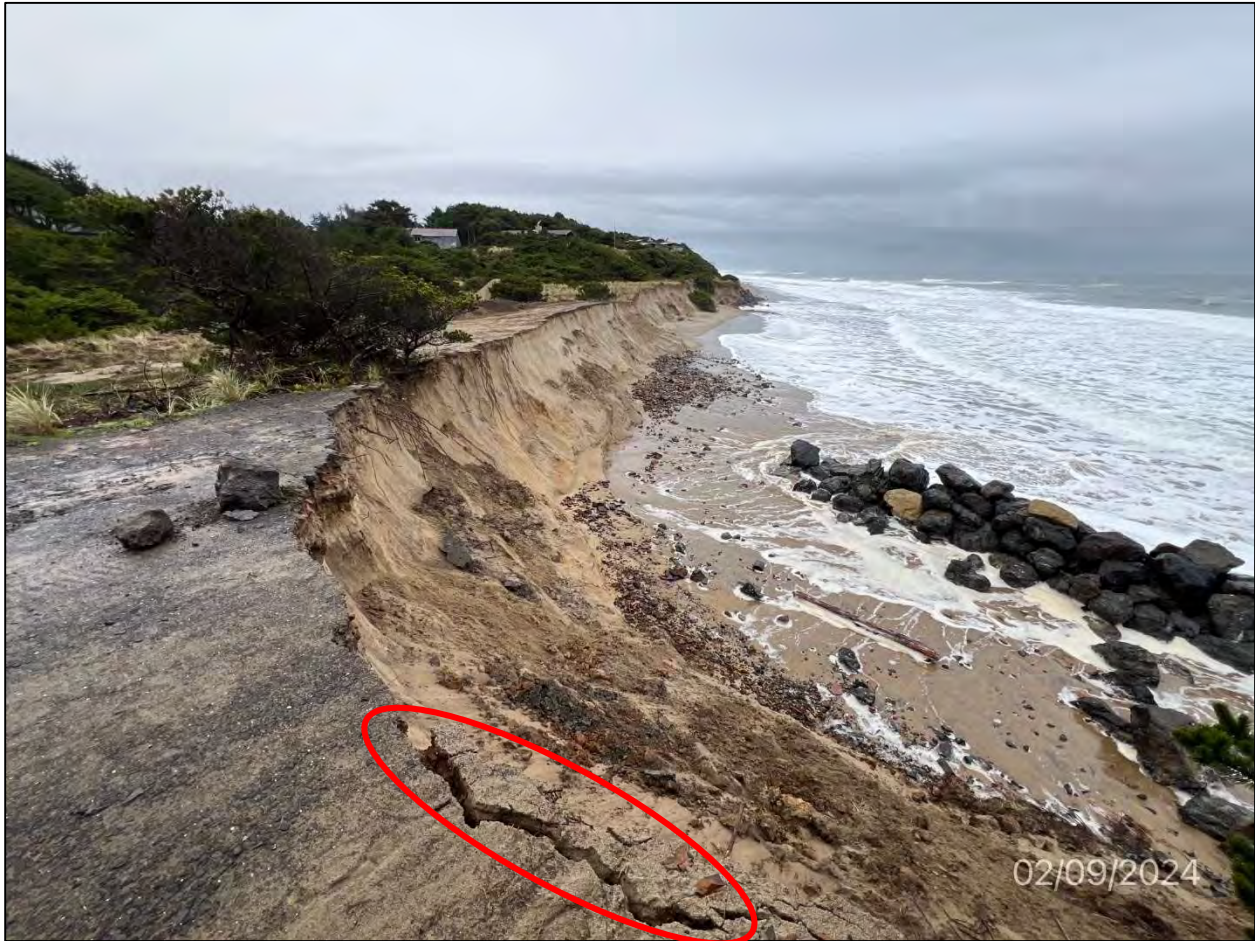
Photo 3: View of subject property dune slope looking south, note the tension cracks circled in red (photo date: February 9, 2024).

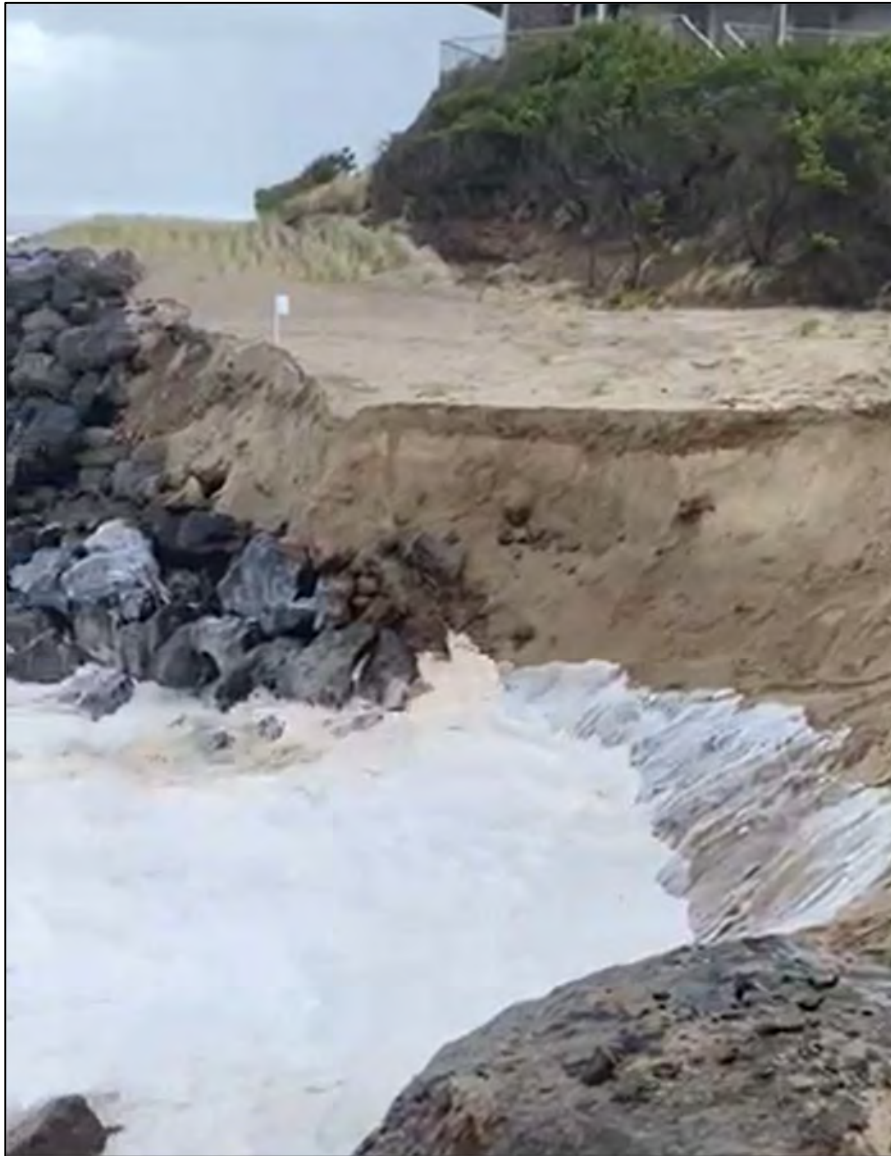
The following three photographs' Photos 4 through 6 show the progression of the erosion at the northern end of the site. The wraparound revetment protecting the residence to the north gets progressively exposed inland. As shown in Photo 3 above and Photo 6 below, erosion has reached the Beach Grass Lane gravel roadway, with the edge of the slope within 30 feet of the Beach Grass Lane pavement.

Photo 4: View of northern property line of subject property (image extracted from client-provided video taken January 9, 2024).

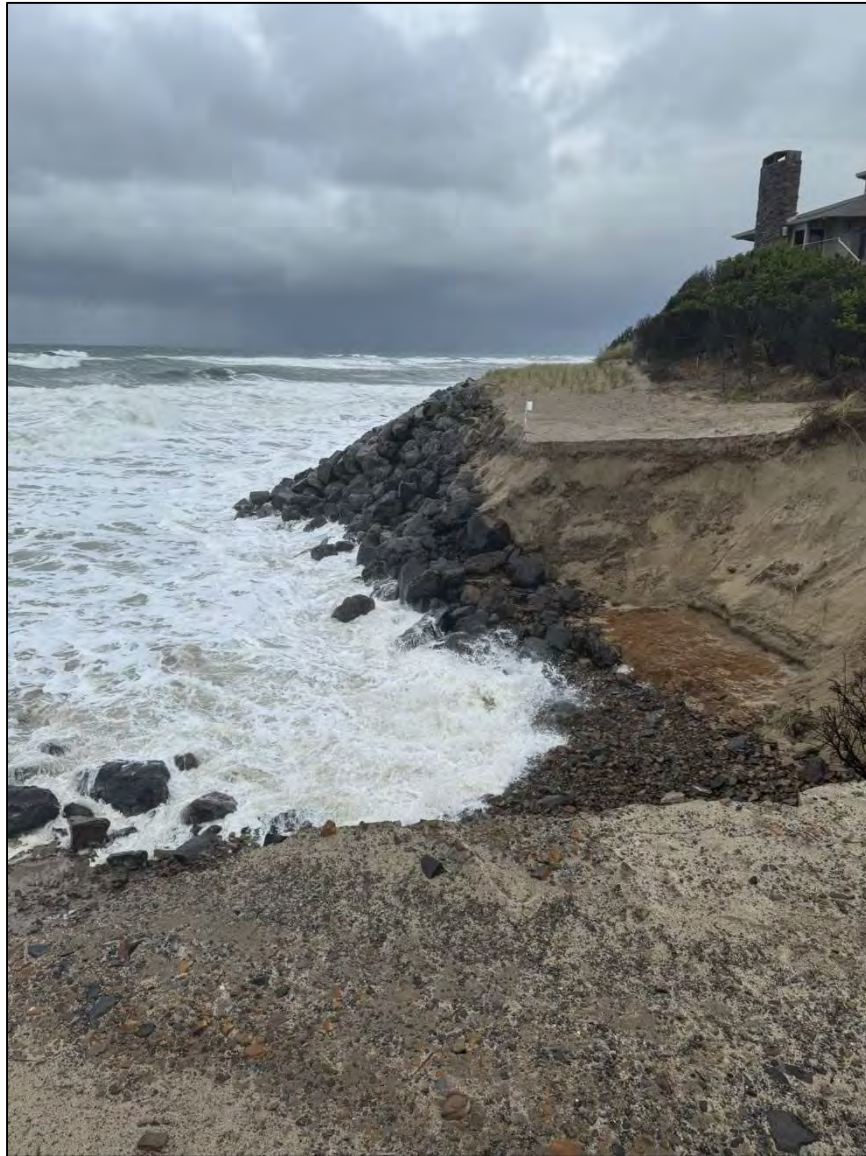
Photo 5: View of the erosion caused by the rip embayments in early January 2024, looking north, same location as Photo 4 (photo date: January 11, 2024).

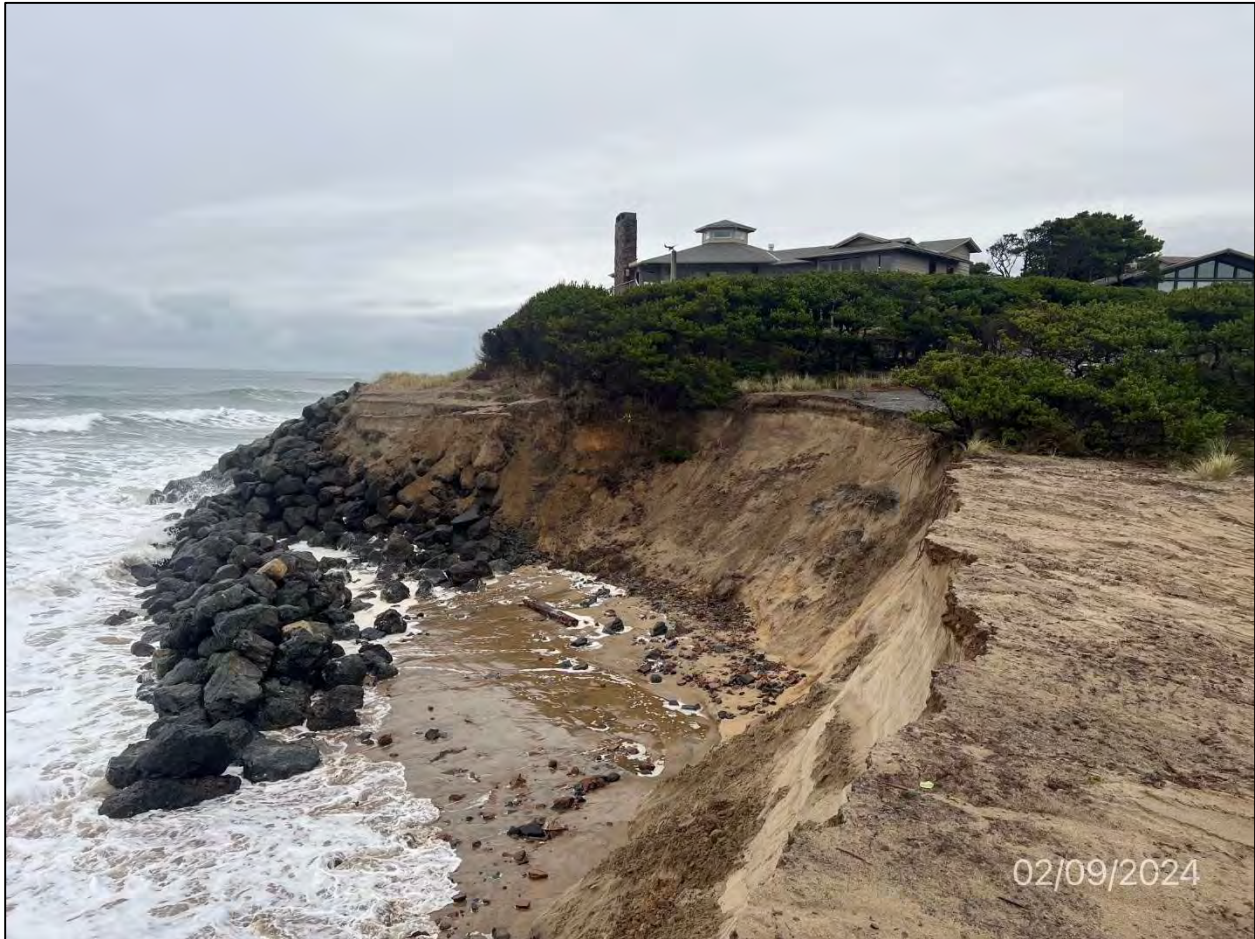
Photo 6: View of the erosion caused by the rip embayments in January and early February 2024, looking north, same location as Photo 4 (photo date: February 9, 2024).

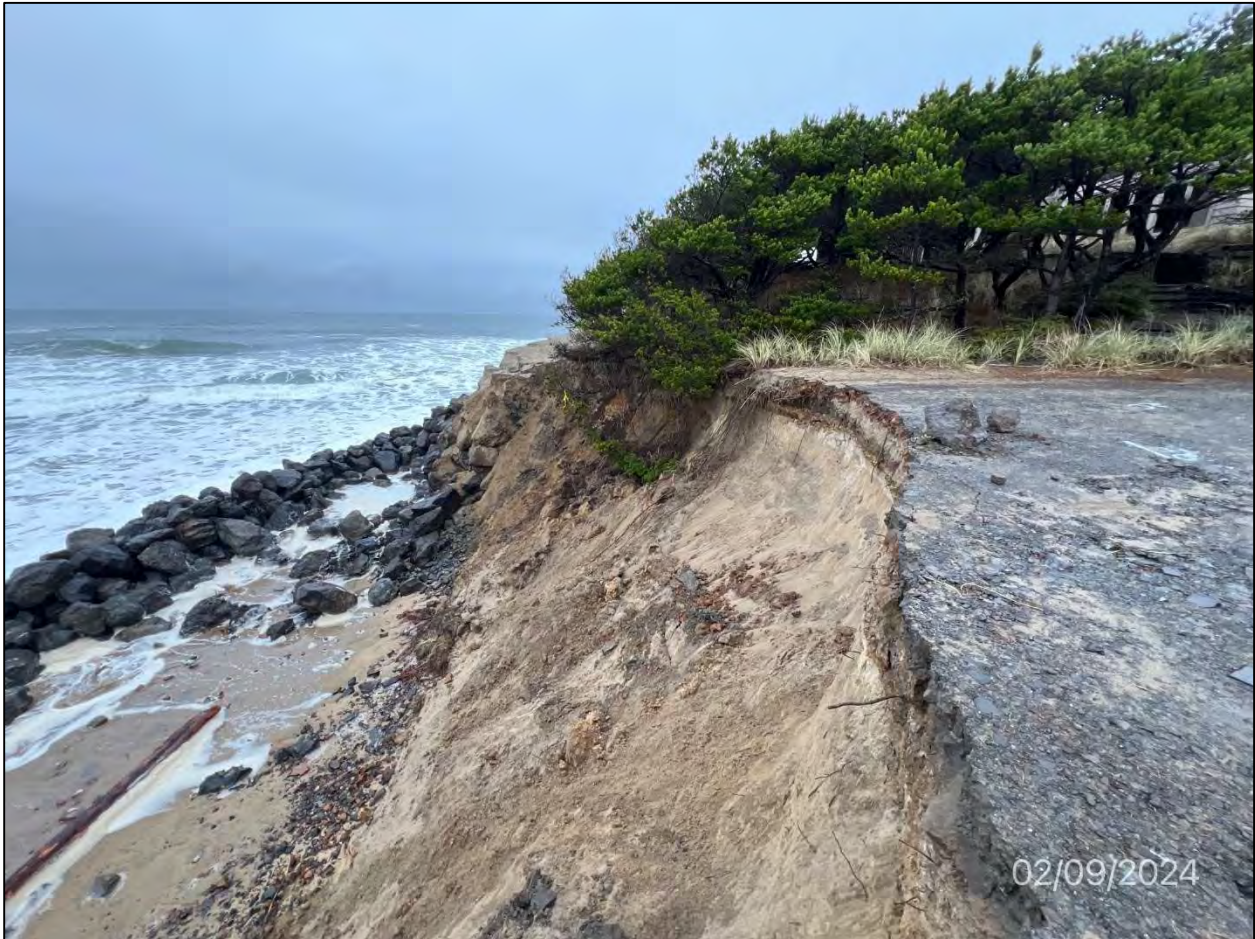
As mentioned and illustrated above, the rip-embayments have been focused along the northern end of the subject property due to the existing wraparound SPS concentrating the wave energy there. The erosion has now started to attack the existing asphaltic pavement of Beach Grass Lane, as shown below in Photo 7.

Photo 7: Beach Grass Lane roadway subject to erosion in early February, looking north (photo date: February 9, 2024).

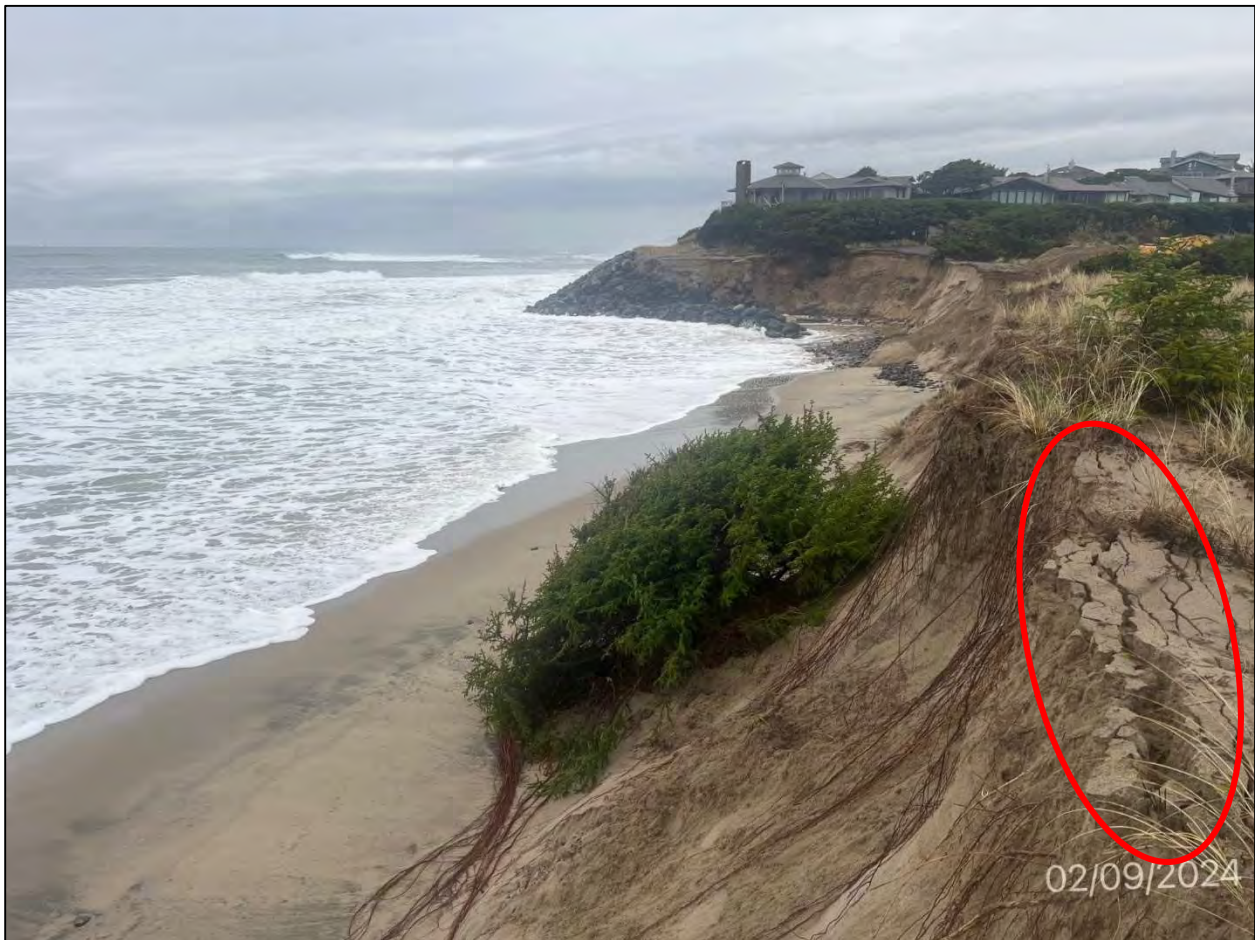
Along the crest of the oversteepened slope, tension cracks are seen to be forming as shown below in Photo 8. Dune sands, such as those at the subject site, have negligible to no tensile strength and only rely on shear strength. These tension cracks decrease the shear resistance to slip failure, and can also contribute an additional lateral force to the soil when water flows into the cracks. This situation causes the factor of safety of the slope to decrease. These cracks indicate that slope movement is occurring, and can often be a first sign of imminent slope failure which occurs when the factor of safety drops below one.

Photo 8: View of the erosion caused by the rip embayments in early January 2024, looking north, note the tension cracks circled in red (photo date: February 9, 2024).

When comparing Photo 1 (June 15, 2023) and Photo 8 (February 9, 2024) above, dramatic erosion along the entire length of the beach is evident. Furthermore, significant erosion has occurred at the northern end of the property, which has now exposed the length of the existing wraparound SPS structure that protects the residence to the north.

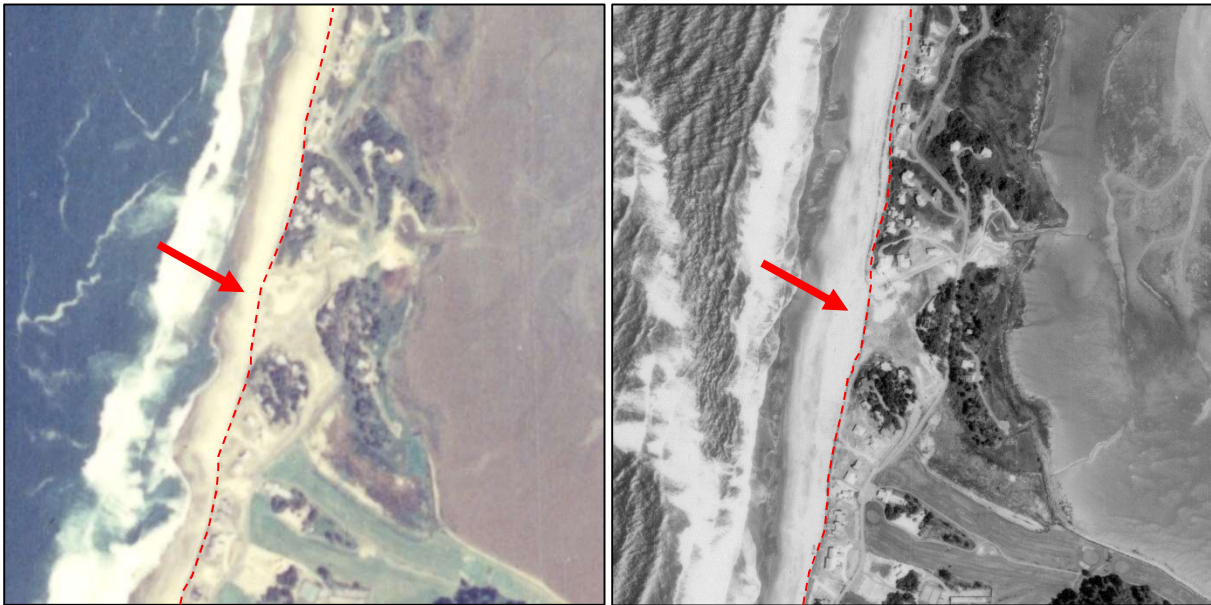
Observing the changes in shoreline condition between aerial images from 1971 and 1972, the subject property experienced erosion as illustrated by the convex to concave transition of the

vegetation line. In the central portion of the common area, the shoreline appears to have receded eastward a distance on the order of 100 feet. A comparison of these two photographs can be seen below in Figure 5.

Figure 5: Comparison of the 1971 (left) and 1972 (right) shoreline shown by red dashed line.

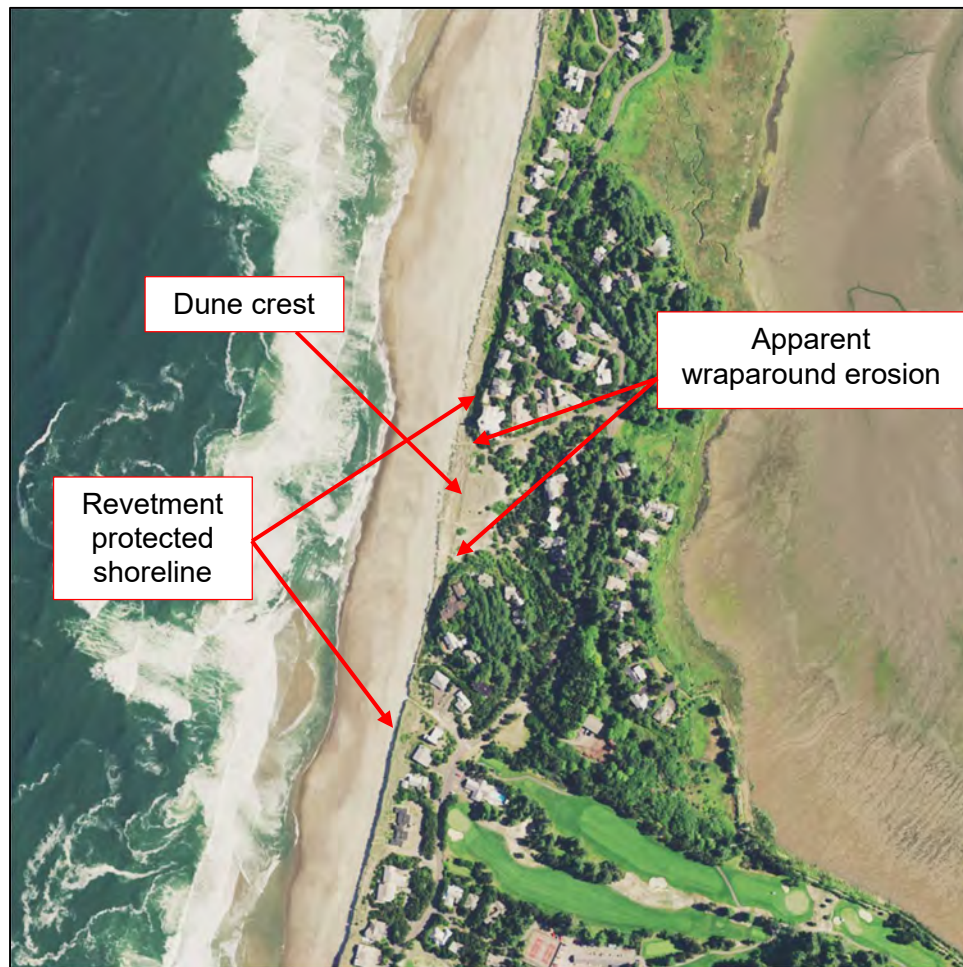
An aerial photograph from 2014, shown below in Figure 6, also confirms that there is erosion occurring on the subject property. The dune crest on the property has moved inland and is beginning to encroach upon the seaward edge of the neighboring residence to the north (i.e. wraparound erosion). Furthermore, the shadows and sharp, relatively straight lines demarking the transition from beach suggest that the existing revetments are protecting the shoreline.

Figure 6: Aerial photograph from 2014.

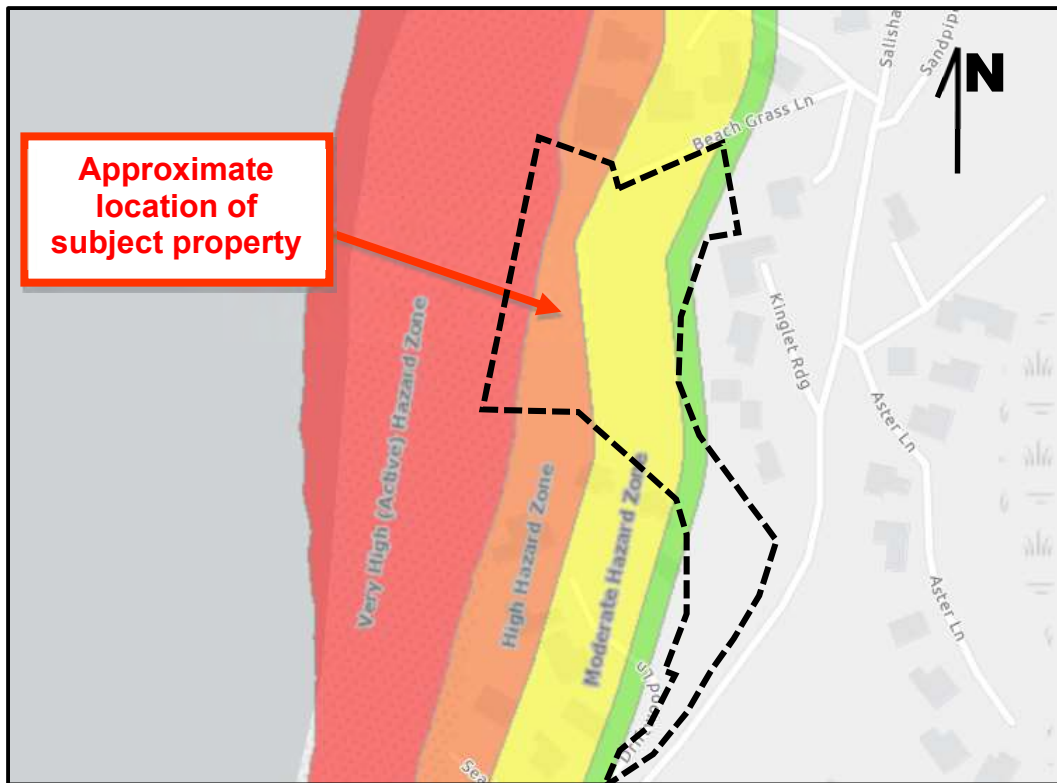
mapping (shown in Figure 7) shows that portions of the site fall within the low, moderate, high, and very high (active) coastal erosion hazard zones.

Figure 7: Coastal Erosion Hazard Zone provided by DOGAMI HazVu.
